BUILDING FEASIBILITY STUDY:

**TOWN OF ST. MICHAELS**  
**TOWN HALL STUDY**

12/28/2016

**EXISTING CONDITIONS FLOOR PLAN**

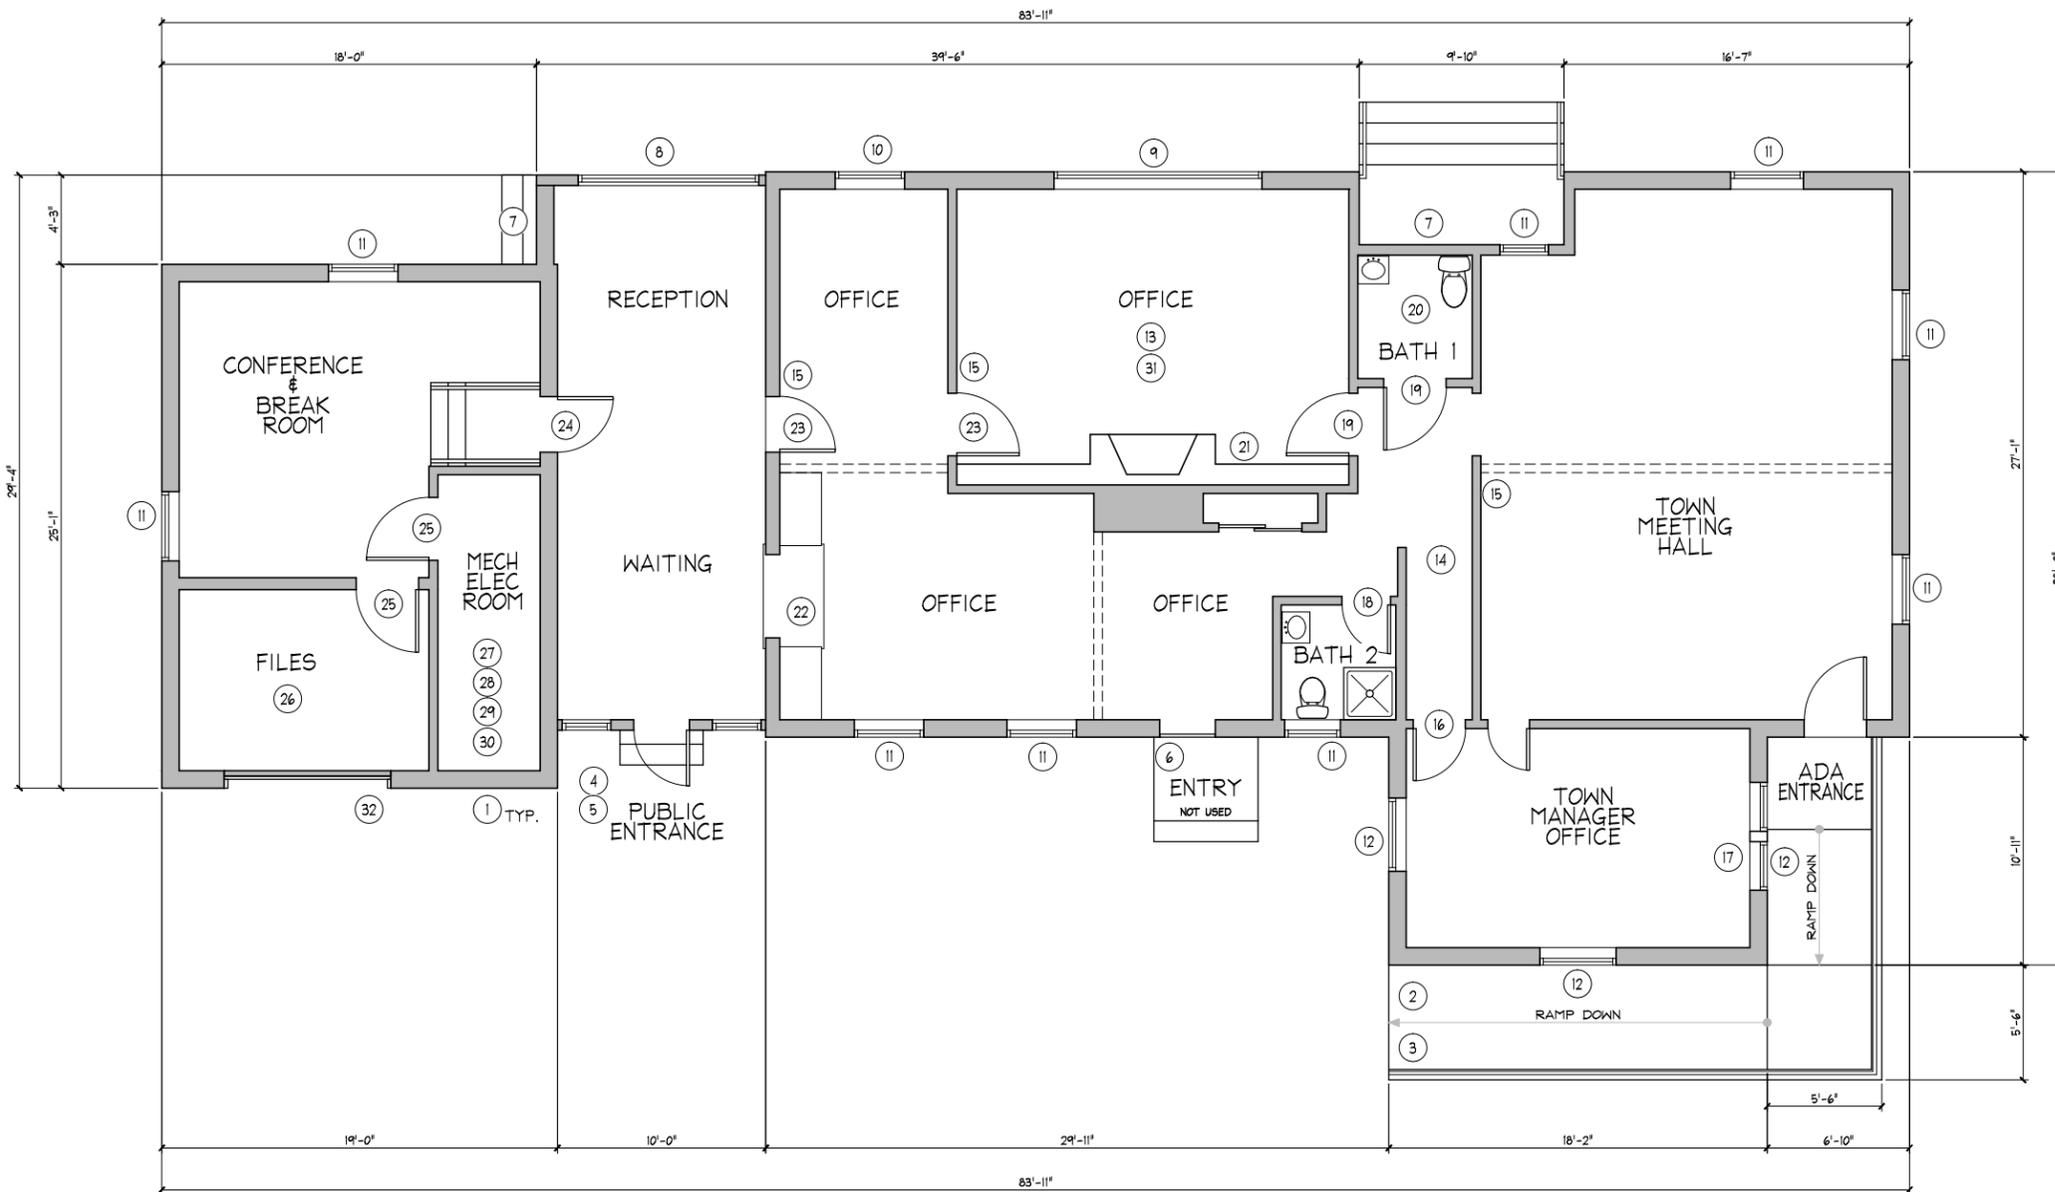
**1 AS-BUILT FLOOR PLAN**  
 A001 1/4" = 1'-0"  
 10/3/2016

1. Brick exterior on wood stud framed walls. Brick and mortar in very good condition except as noted below.
2. Cracked bricks with portion of brick missing, mortar also cracked, limited area near corner.

3. Accessible entrance into building is via ramp to Meeting Hall entry door.
  - a. Brick faced sides in good condition, brick paved surface overall fair condition with some mortar joints and outside corner in poor condition.

- b. Ramp width meets ADA minimum clear width requirements. Ramp slope appears compliant (not verified).
  - c. Ramp railings do not meet ADA requirements. Railings are required on each side of ramp; railing on one side only. Handrail is not graspable in a continuous manner.

- d. Top landing of ramp is less than 30" above grade, so quadrants are not required.
  - e. Steel door is 36" wide, meets ADA minimum clear width requirements. Round doorknob is non-accessible. Door does not have closer.

4. Primary public entry door to Reception is wood with painted exterior and is in fair condition, showing signs of joinery failure due to moisture. Insulated glass seal is intact. Sidelights are wood casement windows with painted exterior and are in fair condition as are wood paneled knee walls below each window. Insulated glass seals are intact. Casement operation not tested.

5. Primary public entrance to Reception is non-accessible entrance. Access is via brick steps, no landing at an out swing door, inadequate door width and round doorknob is non-accessible.

6. Building entrance not used. Door is in fair condition, 32" width, brick steps in good condition, concrete walkway is damaged with hole in surface.
7. Painted wood trim & siding at gables / porch infill are in good condition, paint appears very good.

8. Wood casement windows with painted exterior are in very poor condition with extensive rot. Wood paneled knee wall below appears to be in fair condition (may have hidden decay due to condition of windows). Insulated glass seals are failing. Casement operation not tested.

9. Vinyl casement windows fair to poor condition with double pane glass, some of which are cracked. Casement operation not tested.
10. Vinyl casement windows fair to good condition with double pane glass. Casement operation not tested.

11. Painted wood double hung windows appear to be original to building and are in good condition. Glazing putty is solid and paint appears good. White finish aluminum storm windows properly installed and in good condition.

12. Same as 9, except window needs painting.

13. All interior doors have non-accessible round doorknobs.
14. Lack of storage is leading to hallway being used for storage.
15. Thermostat greater than 48" above finished floor, ADA requirement is maximum 48" high reach.

16. Wood door is 30" wide, non-accessible entrance to office.
17. Built-in casework either side of window and below needs painting.
18. Wood door is 28" wide, entrance to non-accessible bathroom. Fixture clearances are not to current building codes.

19. Wood door 36" wide, meets ADA minimum clear width requirements. Furniture layout encroaches into required accessible door clearance.
20. Accessible restroom. ADA compliant to obsolete standards, sink overlapping water-closet, maneuvering space is no longer ADA compliant.

21. 12" deep built-in casework either side of brick fireplace.
22. 24" deep cabinetry at service window. This service window fails to provide an accessible approach from either side.

23. Wood Dutch door is 32" wide, non-accessible route between work areas. Has 8" high step up from reception room into staff work area, non-building code & non-accessible compliant step.

24. Wood Dutch door is 32" wide, non-accessible route between work areas is via wood steps covered with carpet. Handrails are provided on both sides.
25. Steel door is 36" wide. Threshold is non-accessible. Fire rating not determined.

26. File storage is combination of fixed shelving along two walls and a rolling file system.
27. Sheetrock in mechanical room has unprotected penetrations / holes.

28. Electric distribution is through 200 Amp primary panel. This also feeds a 100 Amp sub-panel adjacent to the primary panel. The electric panels have insufficient clearance in front of panels due to mechanical room being used for storage.

29. Service access to attic located in mechanical room.
30. Heat is generated by oil-fired boiler. Cooling is generated by an outdoor condensing unit. An air-handler delivers heating and cooling to building via air ducts in the attic with ceiling registers. This air handler is connected to the boiler for heat and the outdoor condensing unit for cooling.

31. Crawlspace conditions are not included in this assessment.
32. Garage door not used, covered on inside with file storage shelves. Weatherization / security level not determined.
