# St. Michaels San Domingo Creek and West Side Stormwater and Harbor Infrastructure Assessment and Flood Mitigation Study

Submittal Date: December 6, 2023

**BayLand Consultants & Designers, Inc.**  
7455 New Ridge Road, Suite T  
Hanover, Maryland 21076  
410.694.9401 • baylandinc.com

**Town of St. Michaels**  
Edgar M. Bosley, Jr. Building  
300 Mill Street, PO Box 206  
St. Michaels, Maryland 21663

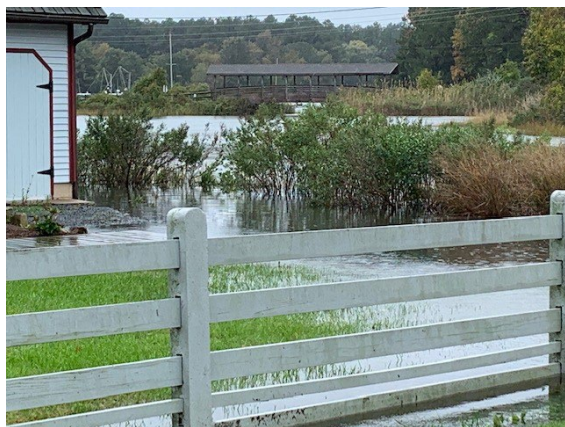
Photo 1 - Flooding at 124 Grace St.

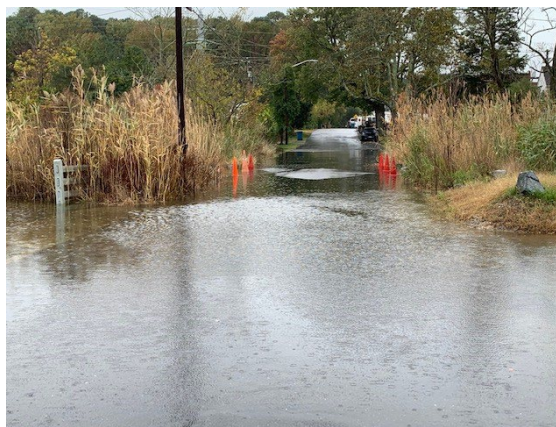
Photo 2 - Flooding at Grace Street Culvert

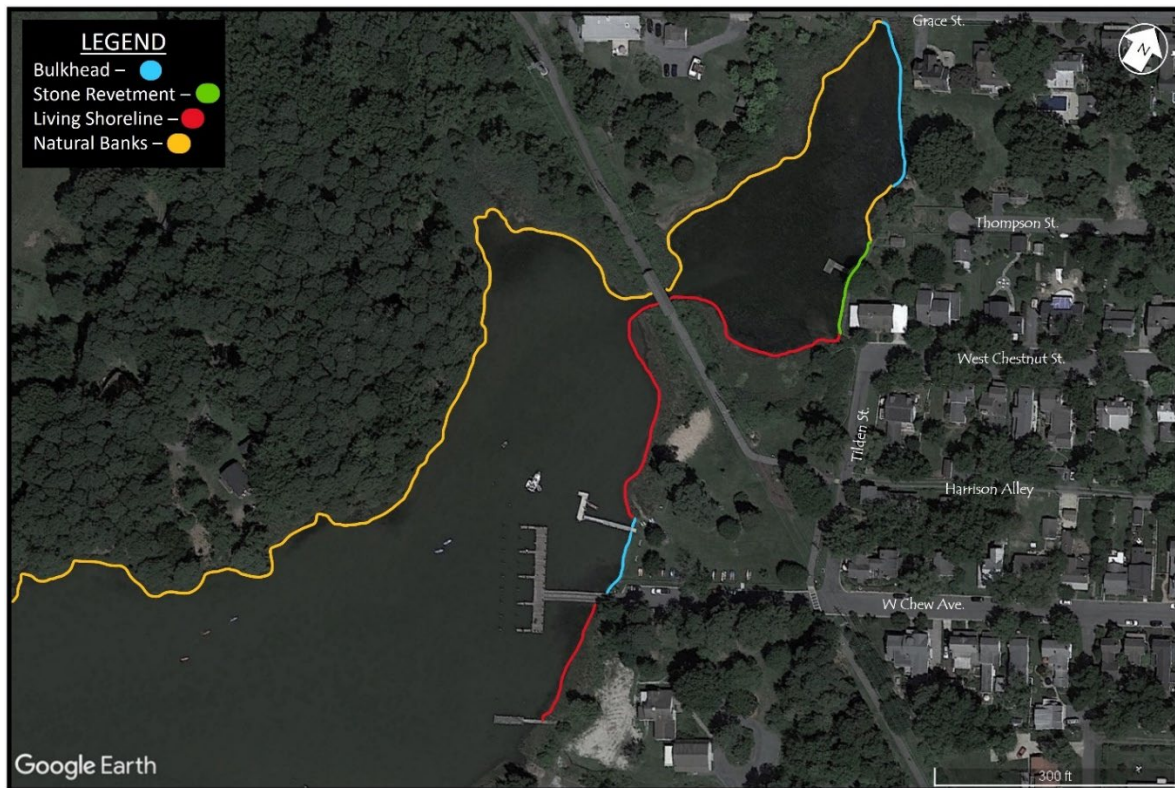
Figure 3 - Shoreline Features

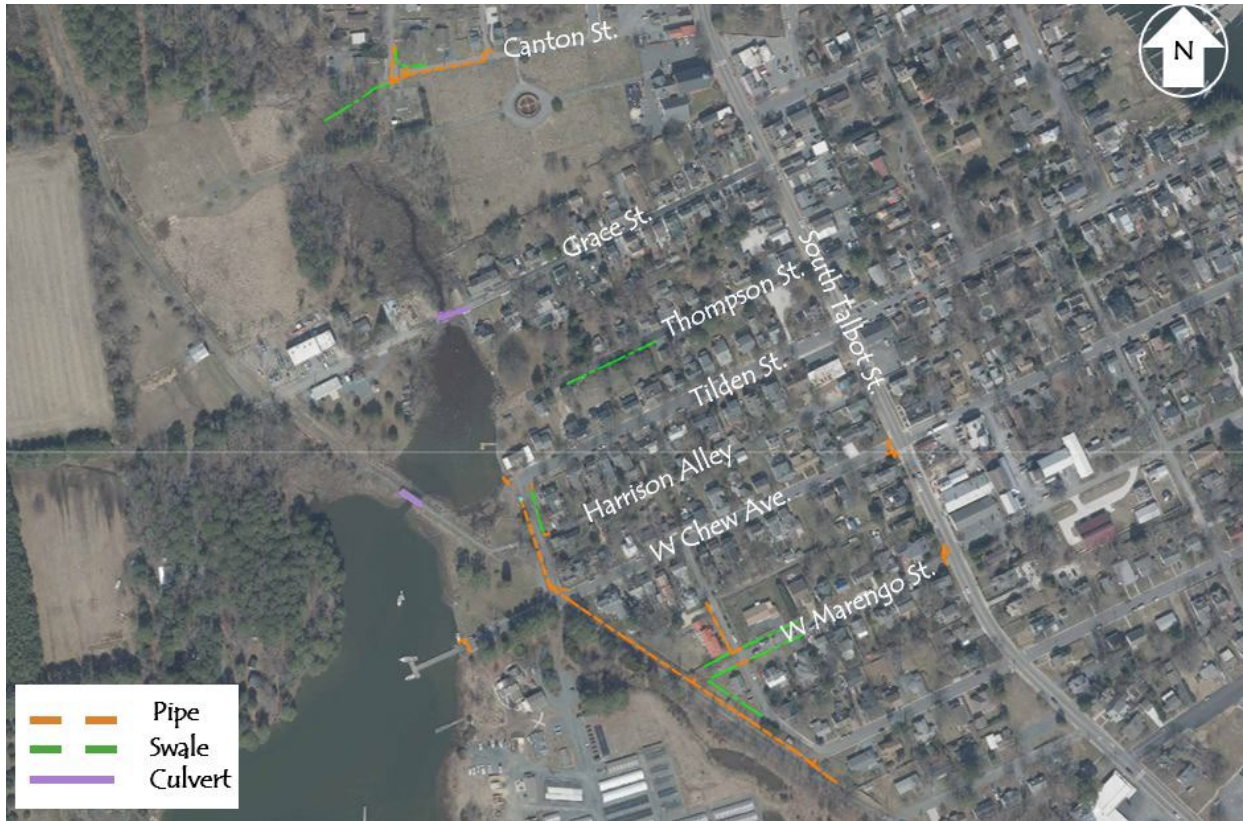
The assessment identified two main connected stormwater systems. First, a stormwater system running along the St. Michaels Nature Trail that outlets flow into a retention facility along the shoreline. Second, a small stormwater system along Canton St. that outlets flow into a swale. The systems both flow towards tidal waters to the west of St. Michaels and feature rain gardens and swales in addition to stormwater drainage pipes. (Figure 4)

Figure 4 - Stormwater Management Features

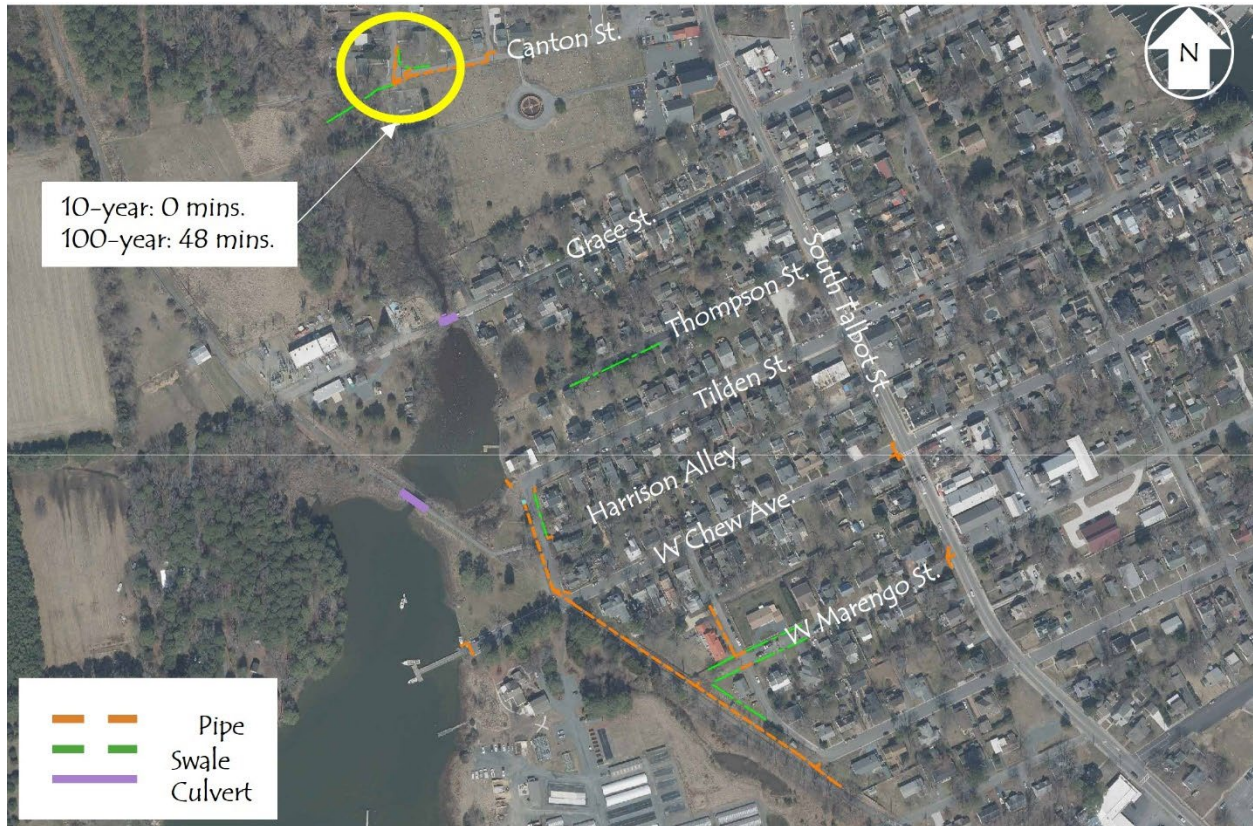
The duration of stormwater flooding was evaluated for the 10-year and 100-year return period rainfall event with current and future conditions. The result of the flood duration modeling for Canton Street at Glory Avenue is shown in Figure 8 and indicate that the 2050 10-year return period rainfall event will not result in flooding while the 2050 100-year return period rainfall event will result in flooding that is likely to drain in less than 1 hour.

Figure 8 - 2050 Stormwater Flooding duration at Canton St. and Glory Avenue

Damage from these flood scenarios could include impacts to the road infrastructure including the pavement, storm drains, electric poles and other utilities that would require repairs. Erosion of flow paths was also observed along the shoulder of the road. Storm surge flooding in 2050 could impact homes and the Choptank Electric Cooperative property with up to 2 feet of flooding.

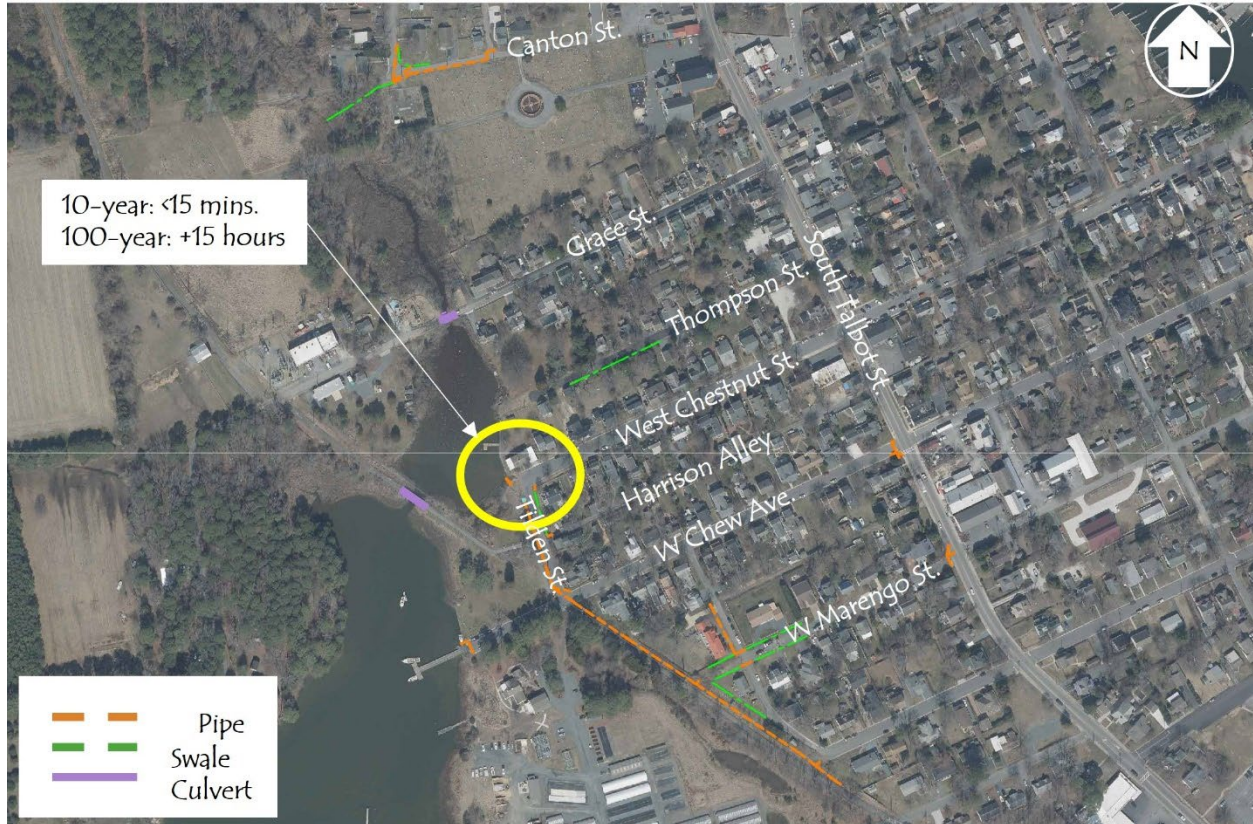
The duration of stormwater flooding was evaluated for the 10–year and 100–year return period rainfall event with current and future conditions. The results of the flood duration modeling for the retention pond located at West Chestnut St. and Tilden St. is shown in Figure 12.

The results of the modeling show that the higher tailwater elevations at the outfall pipe will prevent drainage of the outfall pipe and result in a significant increase in flood duration at this location for 2050 conditions.

Figure 12 - 2050 Stormwater Flooding Duration at West Chestnut St. and Tilden St.

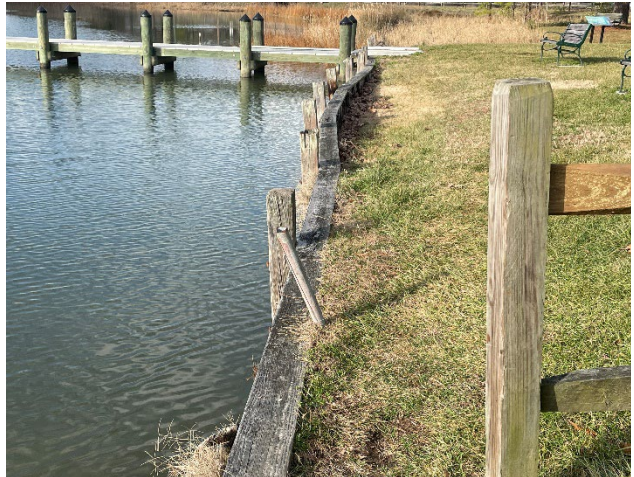
Photo 33 - Failed Bulkhead along Back Creek Park

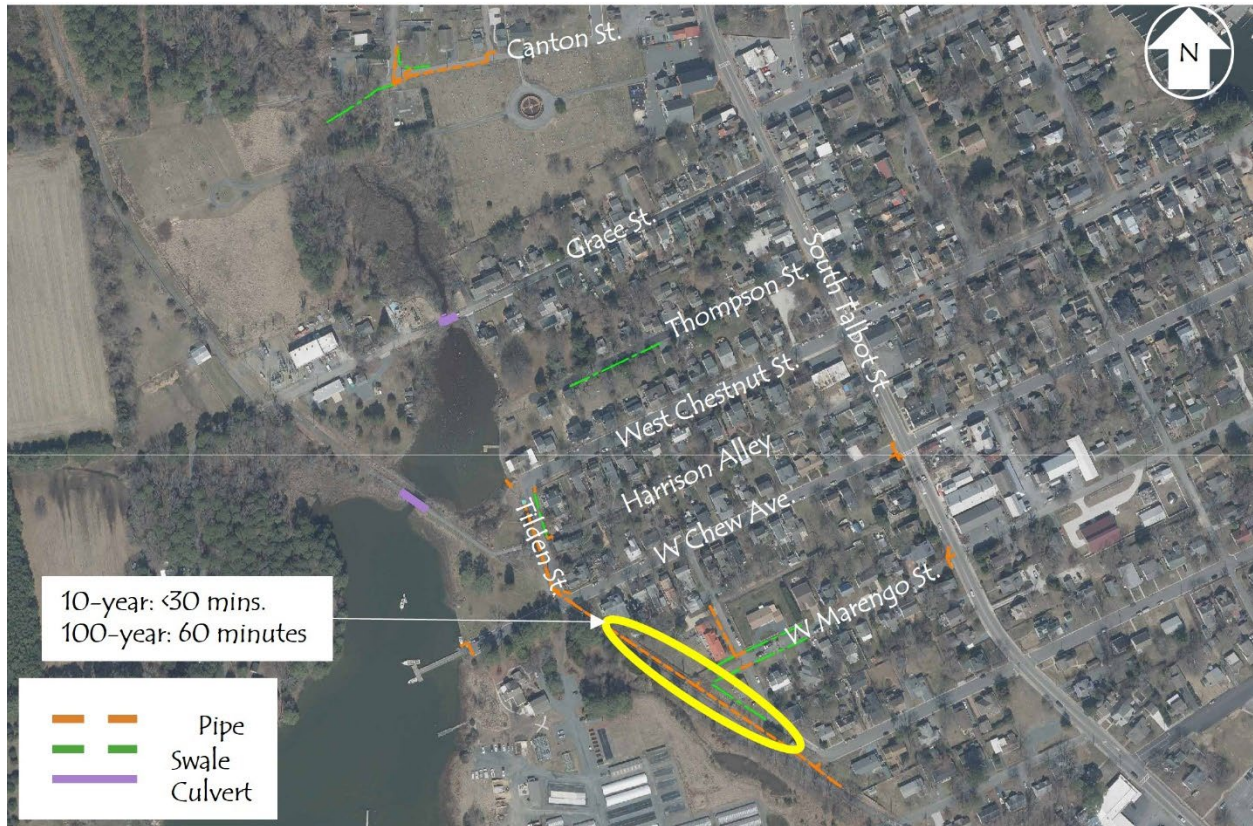
The duration of stormwater flooding was evaluated for the 10-year and 100-year return period rainfall event with current and future conditions. The results of the flood duration modeling for the St. Michaels Nature Trail indicate that stormwater flooding for the 2050 10-year event will result in less than 30 minutes of flooding while the 100-year rainfall event is likely to result in more than 1 hour of flooding in the portion of trail near West Marengo St. The portion of trail where flooding is anticipated is shown in Figure 15.

Figure 15 - 2050 Stormwater Flooding Duration at St. Michaels Nature Trail

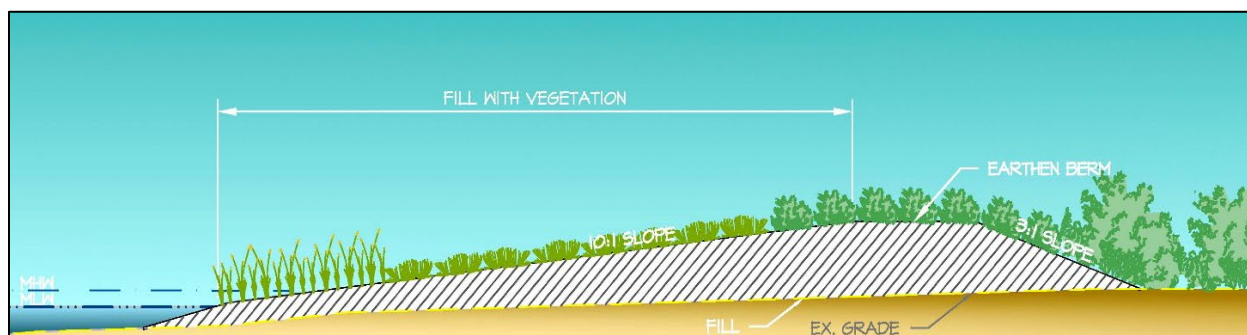
For areas along the natural shoreline where additional habitat could be implemented, an earthen berm can be constructed with a living shoreline on the seaward edge. The living shoreline would provide additional elevation and a wider buffer for the flooding as well as environmental benefits.

Figure 17 - Earthen Berm with Living Shoreline

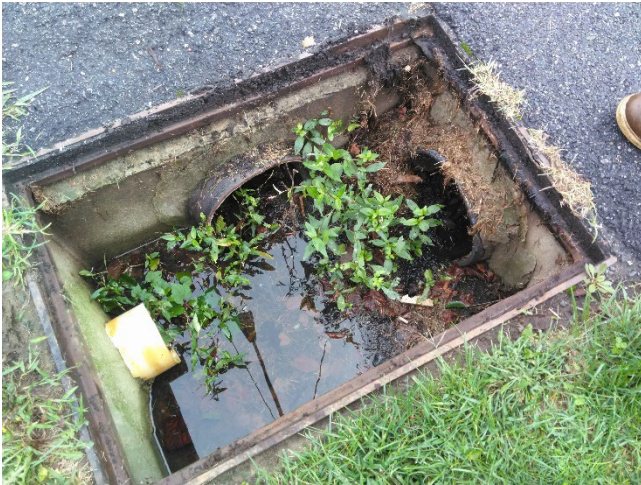
The drainage system along North Street is comprised primarily of swales connected by roadway and driveway culverts (Photo 49 and Photo 50). Along Railroad Avenue, Dodson Ave, and Brooks Lane, the drainage system is a network of storm drain inlets with only a few minor swales to direct flow to inlets. The drainage system directs stormwater runoff to the lower elevations in the east and west. Existing storm drains are generally undersized and have limited capacity to convey flow from larger storm events. Localized flooding is seen on private property and encroaches on homes because poor grading of the lots does not effectively direct water to the existing storm drains. Instead, stormwater runoff must slowly infiltrate into the poorly draining soils, resulting in ponding that can last multiple days (Photo 51 and Photo 52).

Photo 49 - Existing inlet with sedimentation

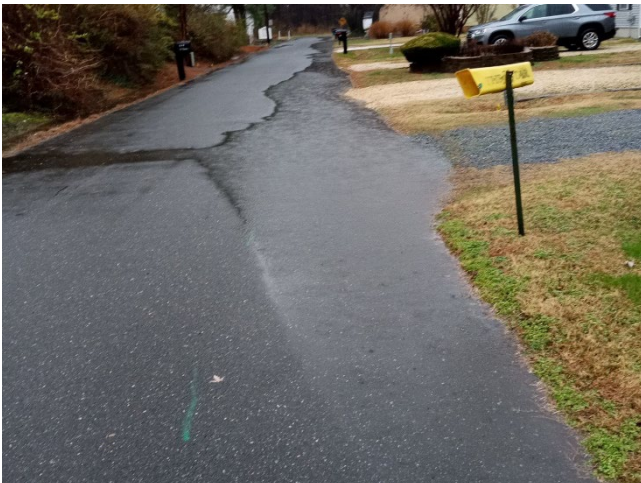
Photo 51 - Water ponding on road surface

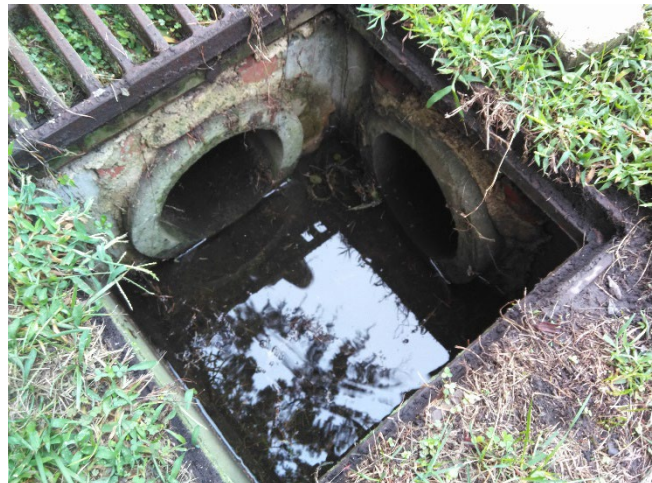
Photo 52 - Flooding of storm drains

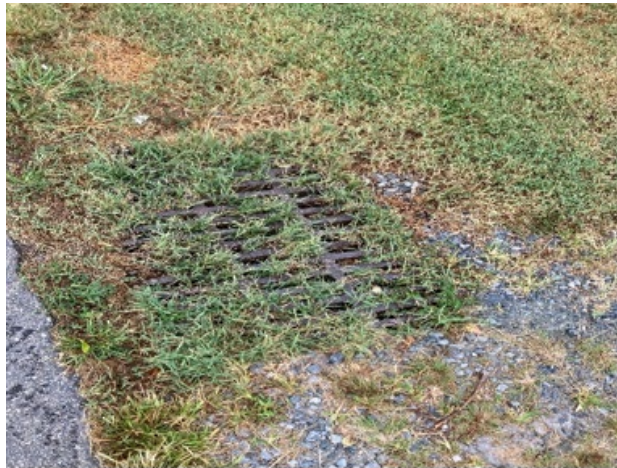
Photo 53 - Sedimented and overgrown inlet

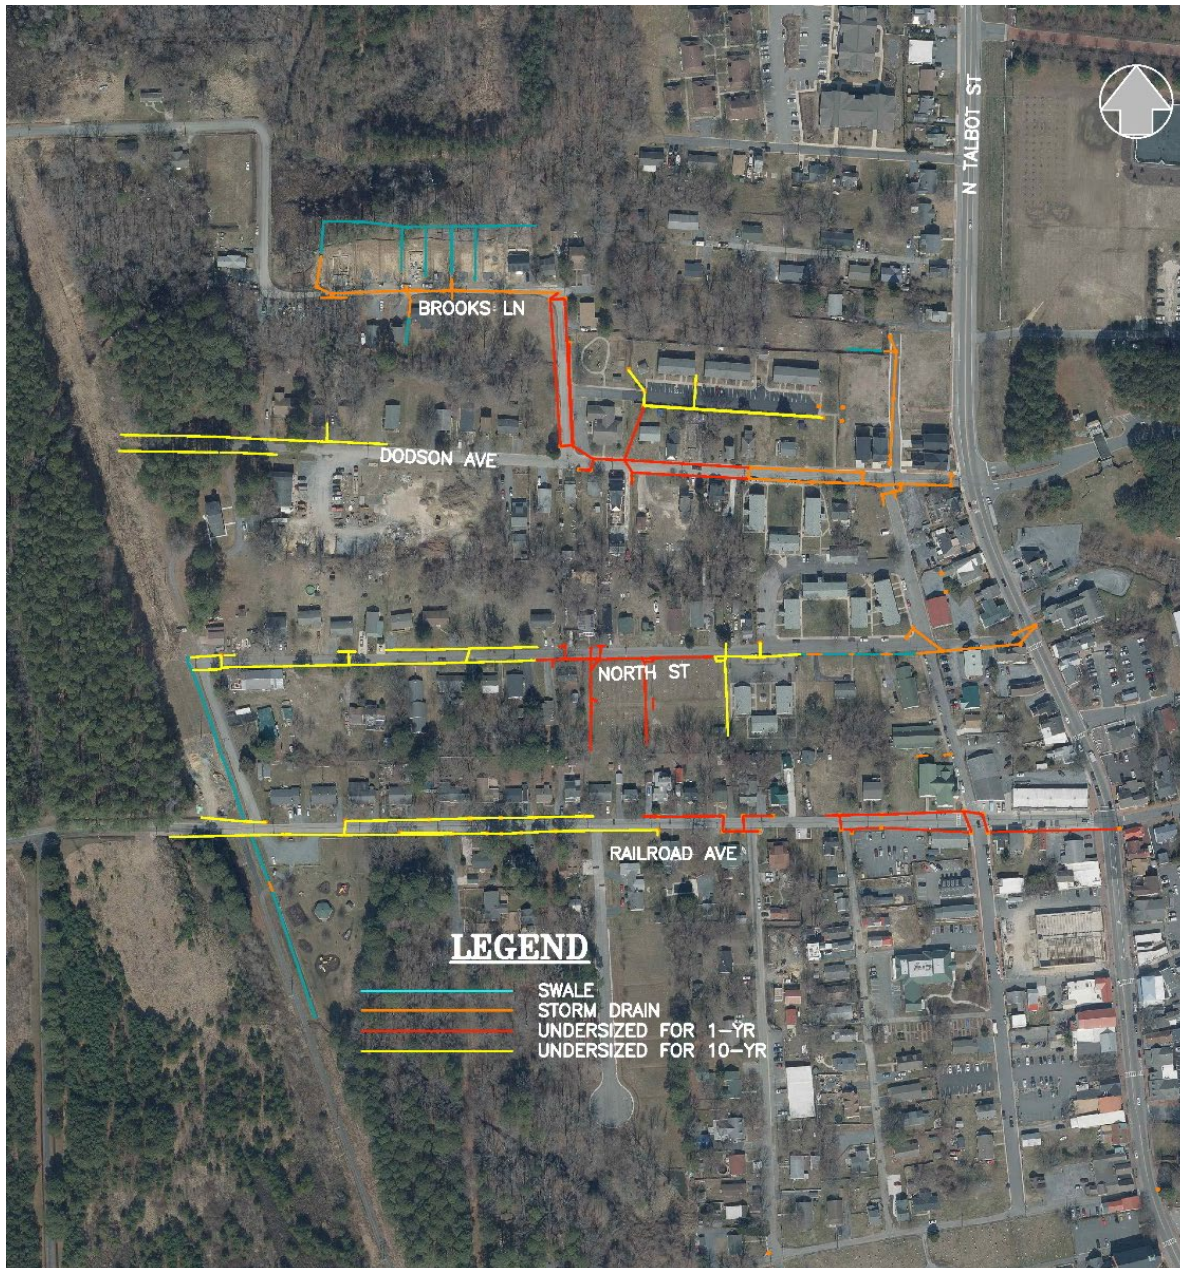
Figure 25 - Culvert Capacity
