ARCHITECTURAL GUIDELINES

# TALBOT STREET HISTORIC AREA ST MICHAELS, MARYLAND

a project of Historic St. Michaels-Bay Hundred, Inc.

Ekstrom and Associates / Richmond, VA

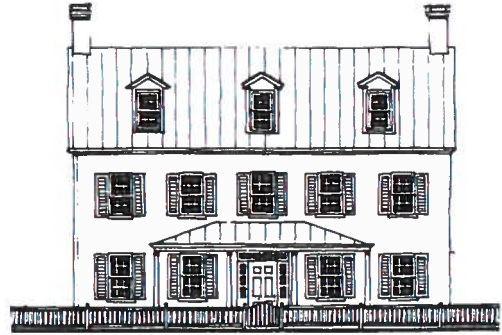
#### 412 S. Talbot Street

In his review of the "Principal Buildings in the St. Michaels Historic Area", Paul Touart describes the Colonel Kemp House in the following way: "Built around 1805, this two-and-a-half story Flemish and common bond brick house is covered by a steeply pitched asphalt shingle roof that is pierced by gabled dormers. The five

bay, center hall house is extended to the rear by a two-story common bond brick service wing. The Kemp House is a crucial building that links three other structures which share the same mantel design and period workmanship. The Bruff House and the Bruff-Mansfield House have identically carved mantels. The sameness in molding profiles and design suggest a shared joiner, John Bruff, who is documented as one of St. Michaels' turn of the nineteenth century craftsmen. Lastly, the Kemp house occupies a pivotal and prominent location on the corner of Talbot and Chestnut streets in the heart of St. Michaels."

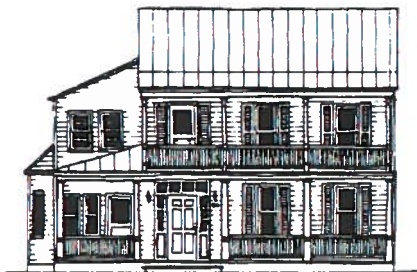
408

Shown on the 1891 and 1901 maps.

The porch at the corner is not shown until the 1927 map.

**Suggestions:**

When required, the composition shingle roof could be replaced with a seamed metal roof.

Replace the second floor storm door with a storm door that matches the wood door.

Check foundation under porch.

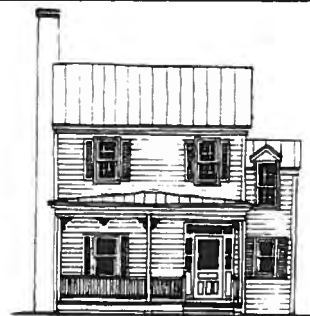
402

When required, shingle roof could be replaced with seamed metal roof.

Check the condition of the masonry work in the chimney and repair if required.

Replace the window on the porch with window or windows similar to the windows originally in the house.

Take care not to add detail that was not part of the original house.

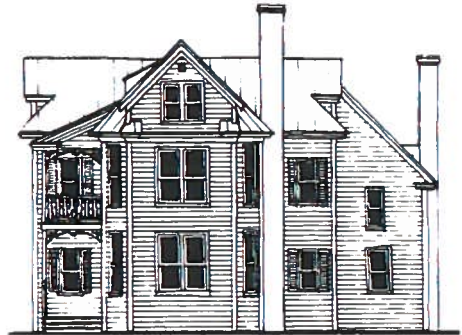
#### 400 S. Talbot Street

Shown on maps in 1891, 1901, 1907, and 1927. An addition compatible with the design of the house has been added.

This house is of particular importance and should be preserved and maintained as well in the future as it has in the past.

**Suggestions:**

Move vent fan and air conditioning units to locations that cannot be seen from Talbot Street.

When required, the shingle roof could be replaced with a seamed metal roof.

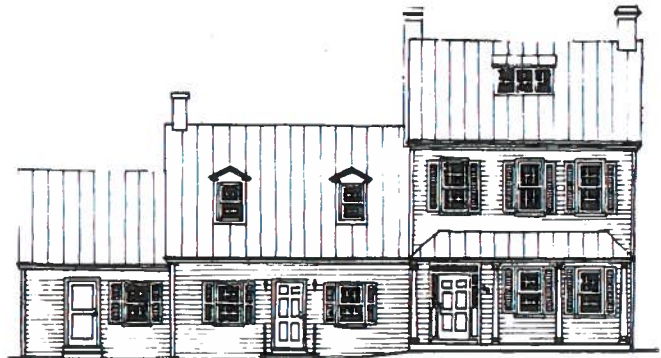
312

**Notes:**

See Individual Building Study  
Number 1, Leonard Funeral Home

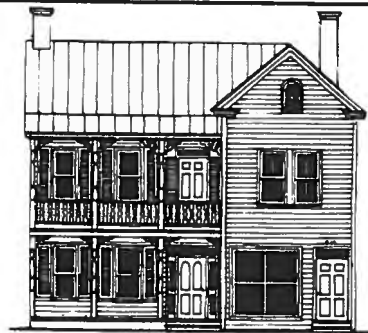
310 S. Talbot Street

Notes:

See Individual Building Study Number 2,  
Valerie's Salt Box

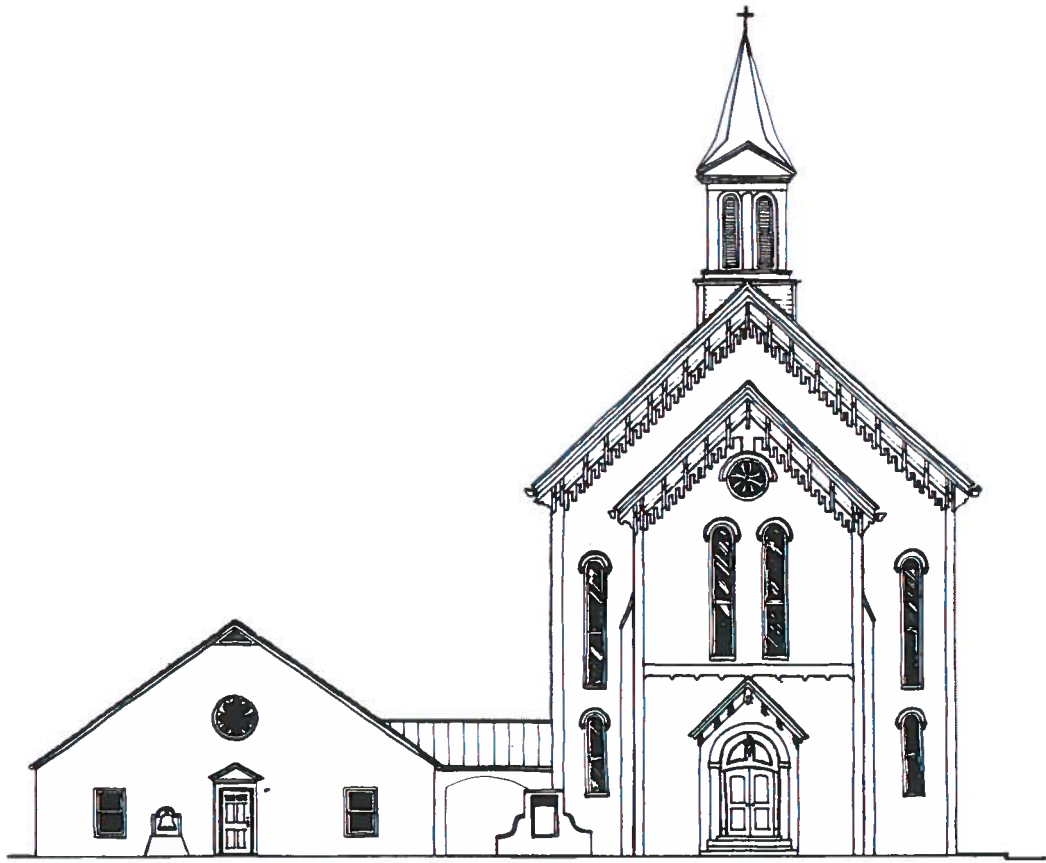
### St. Lukes Church

This fine church is important to St. Michaels because of its distinctive style, its contribution to the towns skyline and because of its position at the south end of the central business district.

In his review of the "Principal Buildings in the St. Michaels Historic Area" Paul Touart describes the church in the following way: "St. Luke's Methodist Church is the most distinctive Italianate style building in St. Michaels. The decorative exterior brickwork, the round arched windows with arched brick hoods and the heavily bracketed eaves are all features which comfortably classify this building as Italianate. Dated to 1871, the gable front brick church was built in several stages. After initial construction of the main block, a single story annex was attached to the west gable in 1894. The adjacent fellowship hall was built in 1961, and finally, in 1971 an entrance vestibule was attached to the front of the church in order to add an elevator. The two-story rectangular brick church was raised with a combination of stretcher bond and common bond brick walls. The main facade was built in pressed stretcher bond brick, while the side and rear elevations were executed in eight-course common bond. A steeply pitched slate roof covers the main building in addition to the various additions. A frame belfry rises from the top of the church."

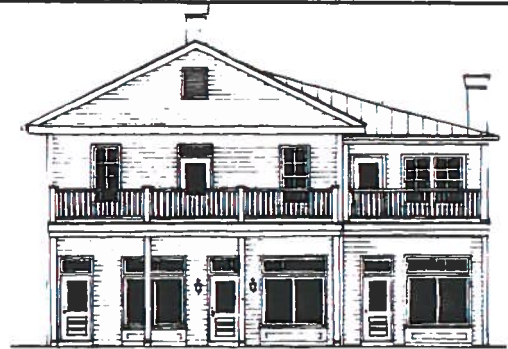
413

The 1901 and 1907 maps showed a similar building with a porch across the Talbot Street elevation.

The 1907 map noted that the building was a grocery and hardware store and the 1927 map showed the building as a two-story cinder block auto repairing structure.

Two gas pumps were shown in front on Talbot Street.

It would be very difficult for this building to conform to the more delicate architectural character of its frame neighbors without replacing it completely. The maps indicate that this rough, massive building provided a discordant note on Talbot Street for many years. Possibly this discord is an important element in the overall character of the Historic Area and until economic forces dictate its replacement, it can be appreciated for its difference.

The picture windows could be replaced by storefront windows with transoms and bulkheads.

The storm doors could be replaced with wood storm screen doors matching the doors behind them.

The air conditioner could be placed in a position that would not be seen from Talbot Street.

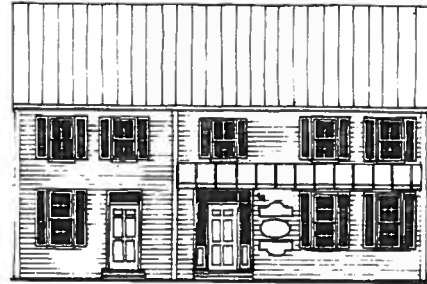
409

The 1901 map showed the two buildings and also noted that the town bell was located in the back yard.

The 1907 map showed the same but noted that the shop was then a plumber's shop.

The 1927 map showed both buildings as dwellings.

The air conditioner could be relocated to a place where it cannot be easily seen from Talbot Street.

When required, the existing metal roof could be repaired, refinished or replaced.

When required, the siding could be replaced with painted wood siding that would more closely match the original wood siding.

When possible, redefine the separation between the two original buildings with a trim board and replace the picture window in the northern portion with a door and a window compatible with the architecture of the Historic Area.

When possible, replace the picture window in the southern portion with two windows under the windows on the second floor.

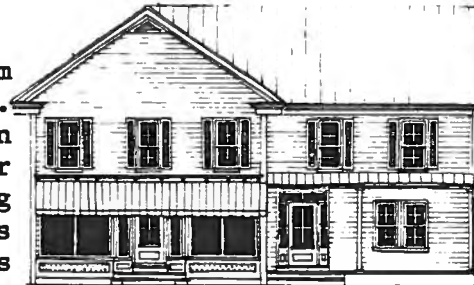
407

In his State Historic Inventory Form description, Paul Touart states "the St. Michaels Pottery Building is an interesting Talbot Street structure for several reasons. The ell-shaped building offers a distinction from other houses nearby, and the period exterior features such as the intact Victorian storefront and principal entrance are unusual in St.

Michaels and are distinctly different from nearby buildings. Few alterations outside a reduction in the size of the front porch have been made to the exterior." In his survey, Mr. Touart notes that the building was built around 1880-1890.

The 1891 map showed a building that could be the northern main portion of the existing building. The building is noted as a two-story grocery store. A coal and wood yard and a scale to weigh the coal and wood are shown to the south between the building and the building next door. A porch is shown across the Talbot Street elevation.

The existing composition siding could be replaced with painted wood siding compatible with the architectural character of the Historic Area. Shutters of the proper size and with appropriate hardware could be installed.

The second floor air conditioning unit could be relocated to a position that cannot be easily seen from Talbot Street.

When required, the existing shingle roof could be replaced with a seamed metal roof.

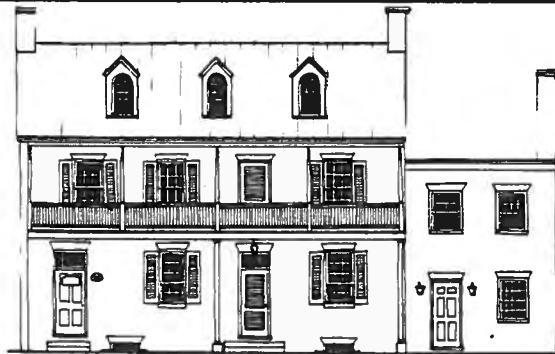
In his review of the "Principal Buildings in St. Michaels Historic Area", Paul Touart identifies this building as the Old Inn and notes that "the Old Inn is one of the more interesting Federal period structures in St. Michaels. Built around 1816, the two-and-a-half story, four bay Flemish bond brick building is distinguished by the

earliest two-story engaged gallery in St. Michaels. A service wing extends from the south gable end of the main house."

In 1891, the building was shown as a general store, with the south wing as a two-story dwelling.

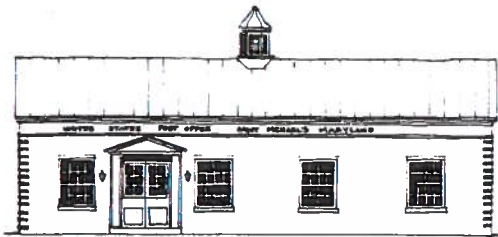
303

The northern one was noted as a drug store, the southern one as a dwelling.

In 1927, a third building was added on the north side. This one-story portion was noted as a shop. The middle portion was an undertaker's establishment and the two-story element at the south end was a dwelling. These buildings occupied a triangular site between the Church and what is now the Bank Building. They have been removed and the existing Post Office has been built close to the bank.

The Post Office, in its current form, does not greatly damage the character of the Historic Area, but if it ceases to be used as the Post Office, its replacement may be considered.

If required, the shingle roof could be replaced with a seamed metal roof.

If no longer needed, the site could be considered for the expansion of the green space and cemetery south of the Church. The eastern portion, at the rear, could be retained for parking and developed as a landscaped parking area.

If it must be replaced by a building, a two-story masonry structure similar in scale, mass and height to the bank should be considered.

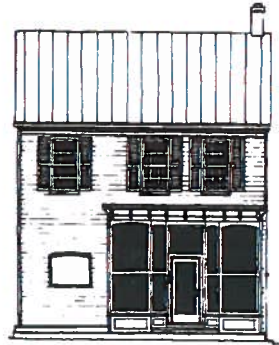
300

The 1901 map showed the building with two bay windows on the front, but no porch. The building was noted as a millinery shop.

The 1907 map showed the same building form but noted that the building was a grocery.

In 1927, the building was shown with its present configuration and is noted as a store.

All four maps showed a two-story dwelling between this structure and the Church.

Repair and refinish the existing seamed metal roof as required.

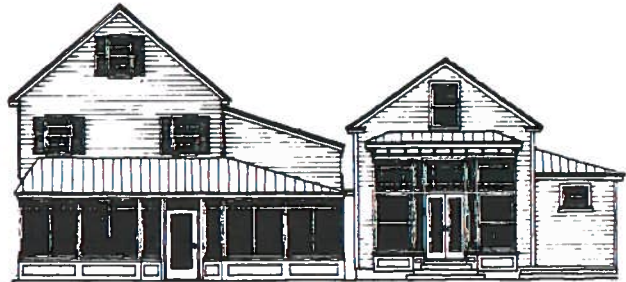
216

The State Historic Sites Inventory Form prepared by Paul Touart in 1986 for the St. Michaels Hardware Buildings include the following summary paragraphs: "The main store building is an altered third quarter of the nineteenth-century frame building that has been partially covered with stucco.

In addition, the first floor storefront has been changed with the construction of a broad eave and large glass display windows. The adjacent store building, on the other hand, appears not to have been altered significantly and is one of the few commercial buildings in St. Michaels to survive with an intact Victorian storefront. This Talbot Street lot, known historically as Canton Row, figures prominently in the commercial history of St. Michaels as the site of Samuel Harrison's brick storehouse. On September 4, 1824, Samuel Harrison advertised in the Easton Gazette, 'a brick storehouse, well fitted, good cellar and counting room, in St. Michaels, in a good stand where the subscriber formerly done business.' This storehouse passed through a series of owner-renters until it burned in 1870. The current structures evidently date to the few years after the fire. There is a structure located at this site on the 1877 St. Michaels map."

In 1891, the southern portions of the building were noted as a general store and office. A separate building at the north was shown as a wheelwright's shop. This northern portion appeared larger than the existing building.

In 1907, the three were noted as a stove and hardware shop, an office, and a millinery shop. Porches are shown on the two end portions. In 1927, the buildings appeared similar to the existing ones. Only the northern portion had a porch. It also had a shed on its north side.

When required, the storefront and the shingled roof over the storefront could be replaced with a storefront compatible with the one to the north.

When required, the shingle roofs could be replaced with a seamed metal roof.

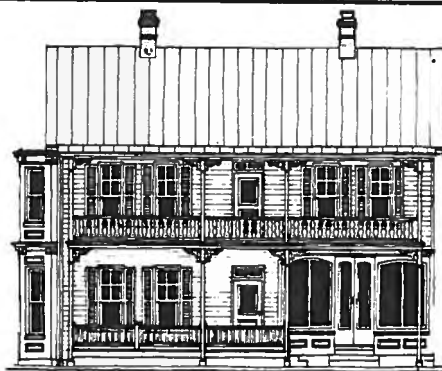
214a

In his State Historic Inventory Form description of this building, Paul Touart states that evidence indicates this building was built 1860-1870 by James Benson. Mr. Touart states that this is "one of the best preserved commercial structures located in the center of St. Michaels. In addition the building displays the array of architectural features found throughout the town. The two-story porch, the two-story bay window, the abundant decorative trim, and the sawn baluster handrails comprise some of the most significant exterior elements. Inside the third quarter of the nineteenth-century finishes remain essentially intact."

The 1891 map showed the building as a dwelling with a shop on the north side. The front porch was shown but no bay was drawn on the south side. In 1901 and 1907, the bay window was shown and the shop was noted as a jewelry shop.

In 1927, the building was shown as a dwelling.

When required, the outdoor carpet could be replaced with materials more likely to have been used in the original building.

Repair and refinish the seamed metal roof, as required.

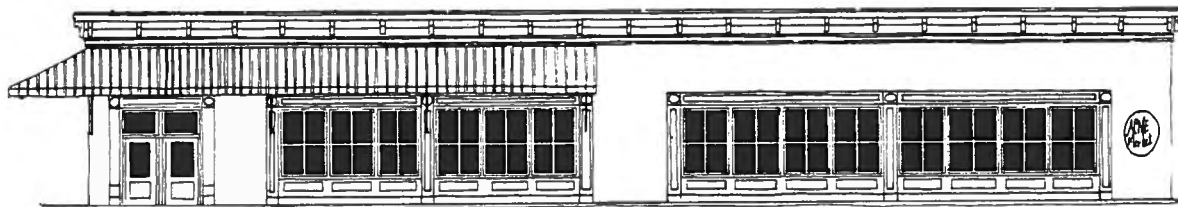
106

In 1927, a cinder block movie house with balcony, a stage and a marquee had replaced the general store. The dwelling and shop remained in the middle. The blacksmith shop had been replaced by a building housing a bowling alley and the Town Hall. The vacant lot had been occupied by a restaurant, a cleaning and pressing shop, and a building supply store.

Until the present building is replaced by two-story buildings more compatible with the character of the Historic Area, the present building could be remodeled to reduce its impact. This might be accomplished by removing the mansard roof, painting the brick a light color or white, and replacing the existing storefront panels and entrance with ones that are more compatible. Awnings could be used to shade the display windows.

The soft drink machines could be moved to the side of the building.

The television antenna could be removed from the roof.

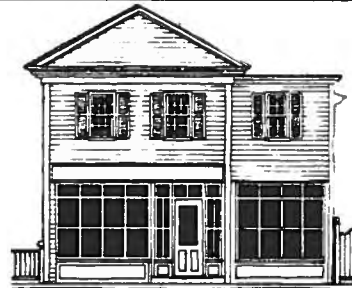
209

In the State Historic Sites Inventory Form, Paul Touart estimates that this building was built c. 1870-1880. In his summary paragraph he states the following: "Hope's Hardware occupies a gable-front frame store building evidently erected during the mid to late nineteenth century. Although the first floor exterior has been altered with the addition of a wide eave, brick facing, and multi-pane display windows,

the second floor has remained intact with a pedimented front and a parapet roof that disguises a shed roofed addition. The interior has been reworked to suit a modern hardware store, however a late nineteenth-century stair survives in the back room."

The 1891 map showed this building without bay windows or porches. The south wing was shown.

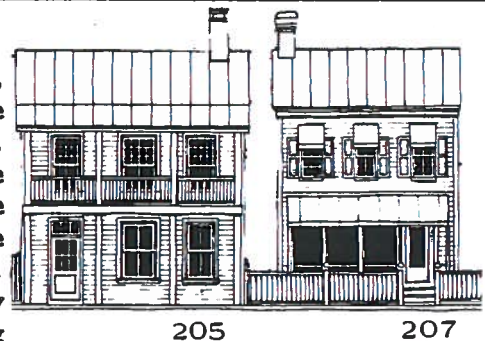
In his State Historic Sites Survey Form, Paul Touart states that the estimated date for the construction of this house is c. 1830-1850. In his summary paragraph he states that this building was "one of the earliest buildings still standing in the central business district of St. Michaels. The two-story frame house was apparently modified around 1900 with the rebuilding of the stair and the replacement of

the second quarter of the nineteenth century mantels. The interior survives with a few period details such as the second floor newel post and a two panel Greek Revival bedroom door. The exterior has retained its basic integrity with flush gable ends, a boxed cornice, and six over six sash windows."

The 1891 and 1901 maps showed a two-story dwelling set at an angle about twenty five feet from the sidewalk. No porch was indicated.

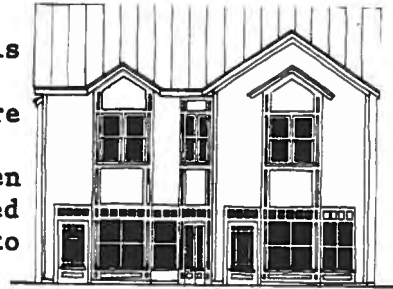
107

On the 1901 and 1907 maps, these buildings were still shown.

In 1927, the two small buildings had been removed and a long slender building was erected along the property line, canted slightly to Talbot Street. It was noted as the Library.

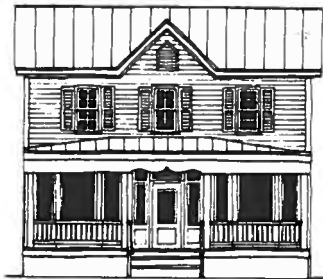
105

The 1927 map showed the dwelling with a porch across the front.

In recent years the porch has been filled in and wide siding has replaced the original.

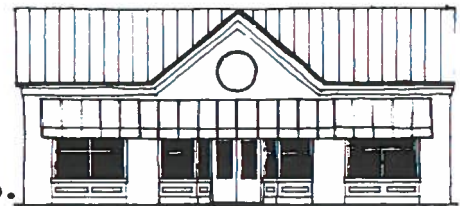
100N

In 1901, the dwelling was still shown but the southern end was shown as a small confectionary shop.

In 1907, the shop was a grocery and meat shop.

In 1927, the building had been replaced by a filling station. Gas tanks were shown in the front yard.

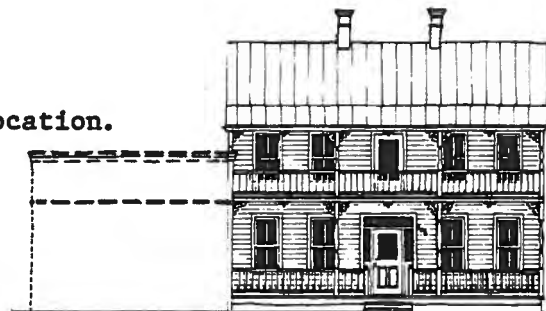
106 N

In this northern gateway section of Talbot Street the character of the area is affected greatly by the individual free standing domestic structures. This building breaks this pattern. This building has

even more importance because of its location. It is facing Mill Street and provides the view for people leaving the Museum area.

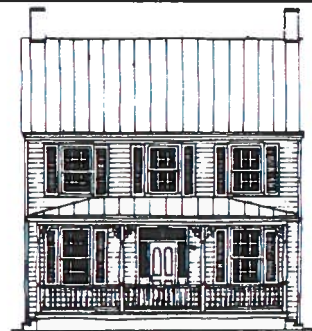
110 N

The storm/screen door could be replaced with a painted wood door that would not detract from the original front door. Shutters of the proper size with the appropriate hardware could be installed.

The windows and entrance could be repaired as required.

The front porch foundation, deck, steps, rail, balusters, columns, brackets and roof could be repaired and refinished.

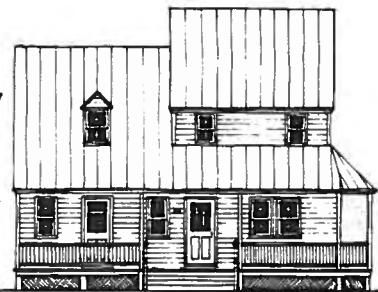
114 N

The 1891 map showed two small dwellings approximately on this site. They were also shown on the 1901, 1907 and 1927 maps.

In recent years, they have been lost and replaced by a single building on the corner. The new building was built at an angle to Talbot Street and includes elements that are not compatible with the character of the Historic Area.

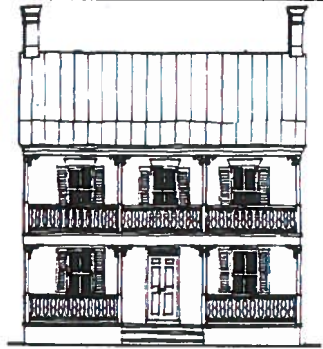
200 N

The 1901 and 1907 maps showed this house and another small building attached to it on the south noted as a grocery.

By 1927, the grocery had been removed and the corner on the north appeared as a side yard for the house.

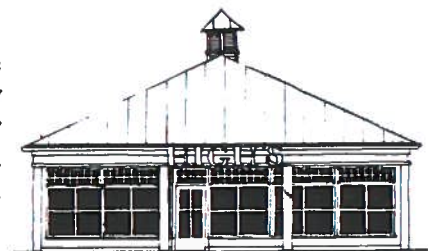
105 N

On the 1901 and 1907 maps, two buildings were shown at the corner of Talbot and Willow Street (now Mill Street). The corner building was a general store in 1901 and a grocery in 1907. The building to the south was shown as a two-story dwelling.

On the 1927 map, the shop was missing and the dwelling remained. In the years that followed, the house was removed and a Highs Store has been constructed well back from Talbot Street. This building is not compatible with the character of the Historic Area. In the future, two-story buildings could be built along Talbot Street in the block between Cherry and Mill Streets, and in a manner compatible with the character of the Historic Area. Parking could be provided behind these buildings. The Highs Store could be renovated to more compatible with the character of the Historic Area.

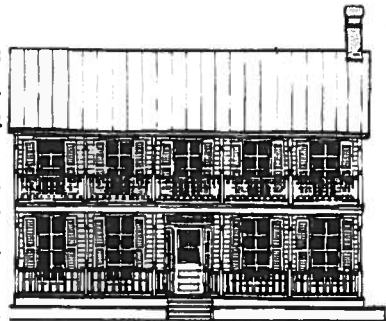
203N

On the 1901, 1907 and 1927 maps, this house was shown as a two-and-a-half-story dwelling with a livery stable behind it. The maps all showed a porch across the front of the house.

In recent years, the second floor gallery has been enclosed with a strip of windows over shingled siding. It is likely that the fenestration on the first floor has been changed to provide only one window on either side of the central entrance.

The spacing of the balusters in the existing rail on the porch is unusually wide and is probably not as originally built.

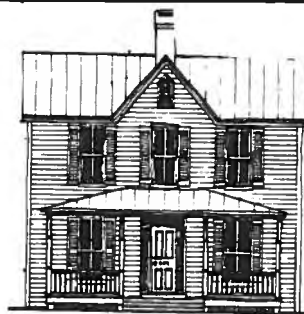
209N

This dwelling was shown on the 1901, 1907 and 1927 maps. Apparently, very little change has taken place over the years and the house has been well cared for. It is an excellent example of late nineteenth century Victorian domestic architecture.

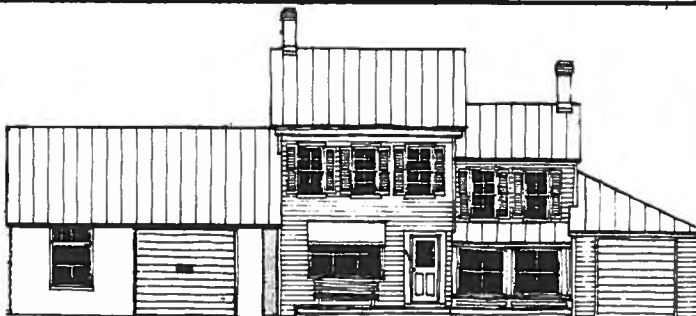
211N

In 1927, it was shown as a filling station with gas tanks drawn in the front yard.

In recent years, garage wings have been added to each end.

This building is important because of its position as the first building in the Northern Gateway section on the east side of Talbot Street.

When required, roofs with slopes similar to the main portion of the building could be constructed over the garage wings. The window of the northern garage could be increased in height and the existing siding replaced with painted wood siding more likely to match the original.

When required, the shingled roofing could be replaced with seamed metal roofing.
