St. Michaels San Domingo Creek and West Side Stormwater and Harbor Infrastructure Assessment and Flood Mitigation Study

PROGRESS DRAFT

Submittal Date: July 28, 2023

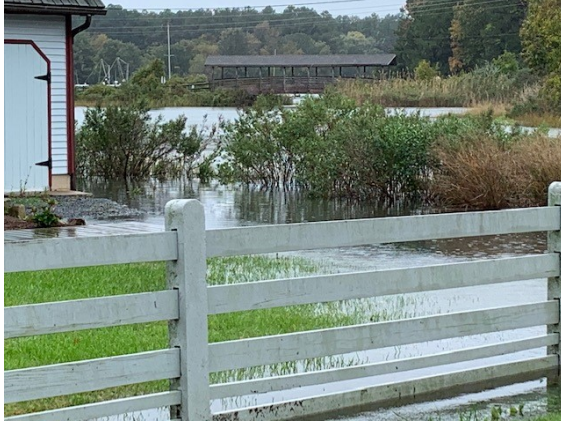
Photo 1- Flooding at 124 Grace St.

coastal and stormwater flooding. Impacts of climate change such as sea level rise and increase rainfall frequency and duration will continue to threaten vulnerable areas with the Town of St. Michaels. Flooding experienced at St. Michaels west end are presented in Photo 1 and Photo 2.

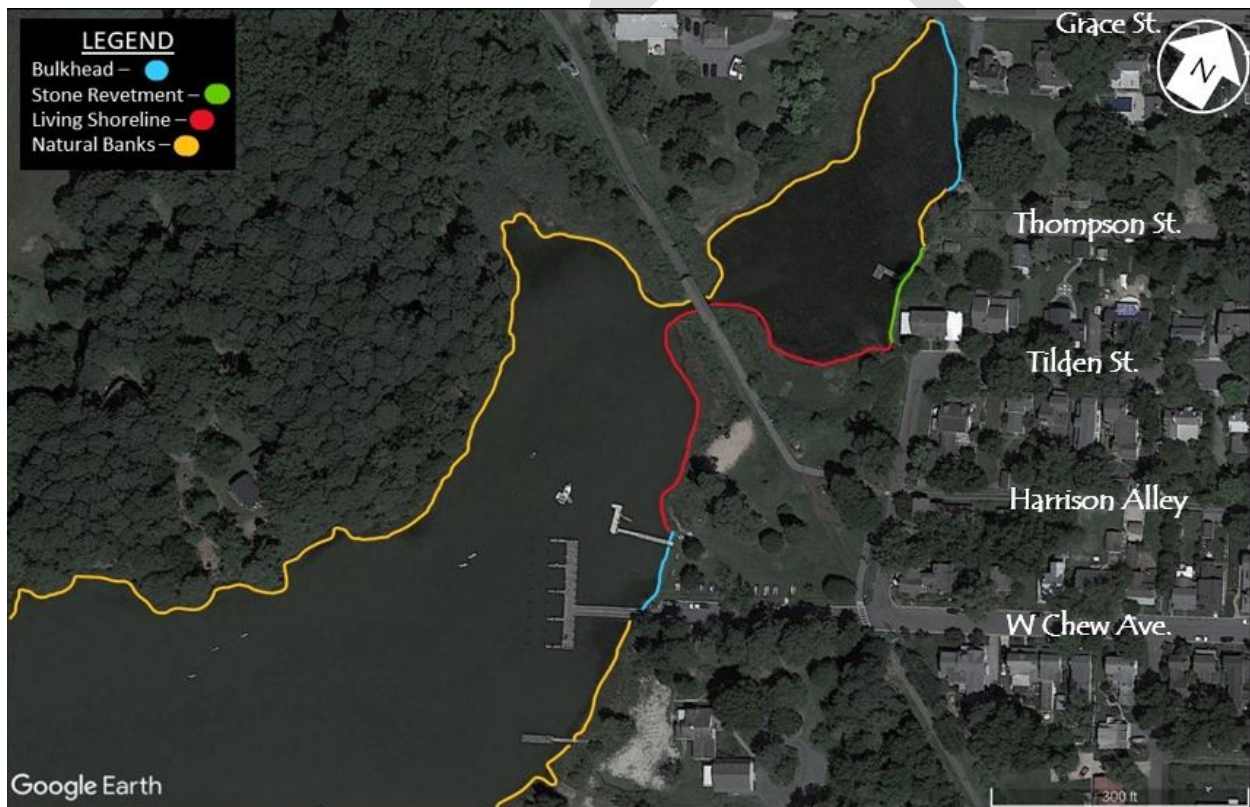
Figure 3 - Shoreline Features

The shoreline along the west side of St. Michaels features various shoreline protection structures such as a living shoreline, bulkheads, a revetment and natural banks (Figure 3).

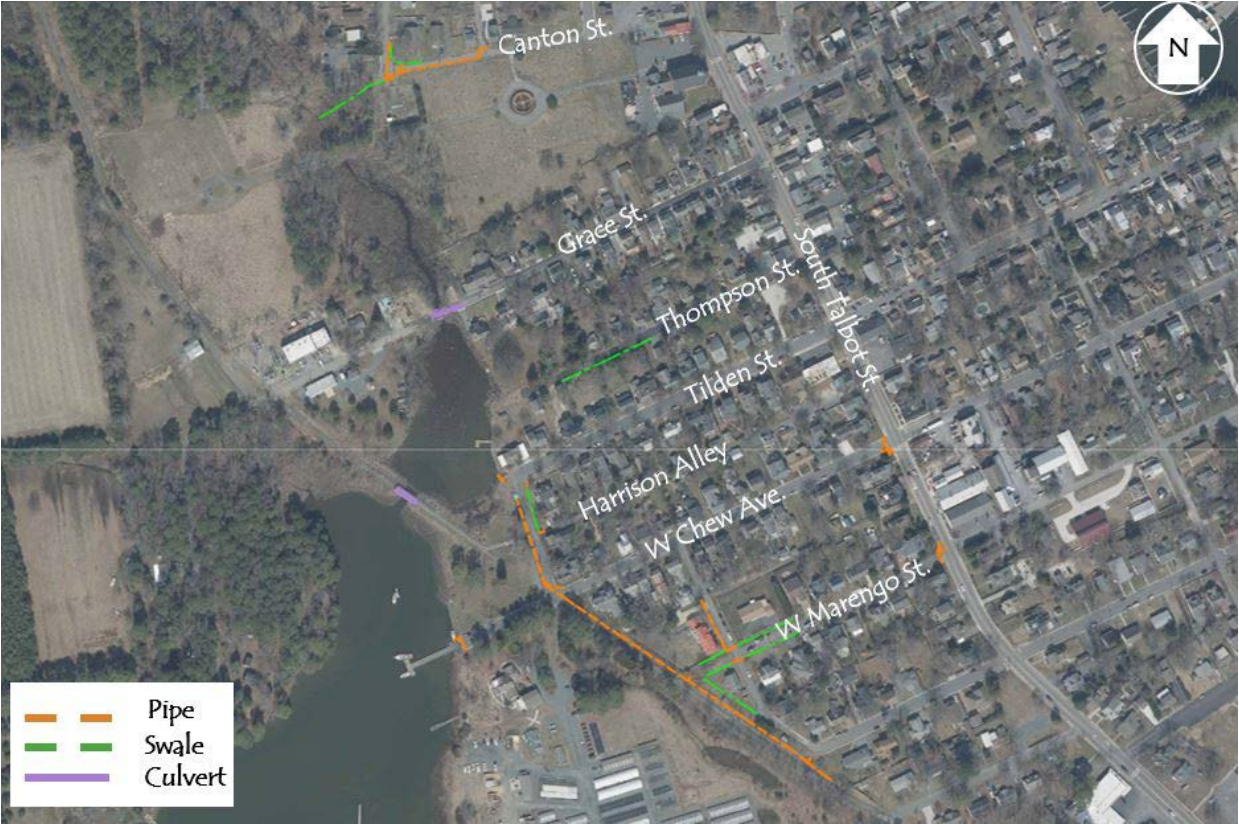
Figure 4 - Stormwater Management Features

The assessment identified two main connected stormwater systems. First, a stormwater system running along the St. Michaels Nature Trail that outlets flow into a retention facility along the shoreline. Second, a small stormwater system along Canton St. that outlets flow into a swale. The systems both flow towards tidal waters to the west of St. Michaels and feature rain gardens, swales, in addition to stormwater drainage pipes. (Figure 4)

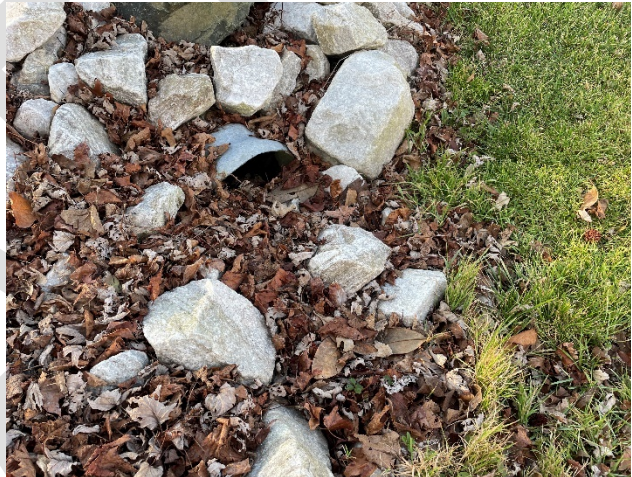
Photo 16 - Outfall along Swale at Canton St.

Canton Street is a narrow, residential road with elevations ranging from approximately +4 to +8 feet NAVD88. The southern side of the road borders the St. Luke's Cemetery and property owned by Choptank Electric Cooperative. The easternmost 750 feet of road is paved (Photo 13), ending at the intersection with Gloria Avenue. West of Gloria Avenue, the unpaved portion (Photo 14) of road leads to homes and the headwaters of San Domingo Creek (Photo 15). Swales with pipes beneath driveways were observed along the southern edge of the road (Photo 16).

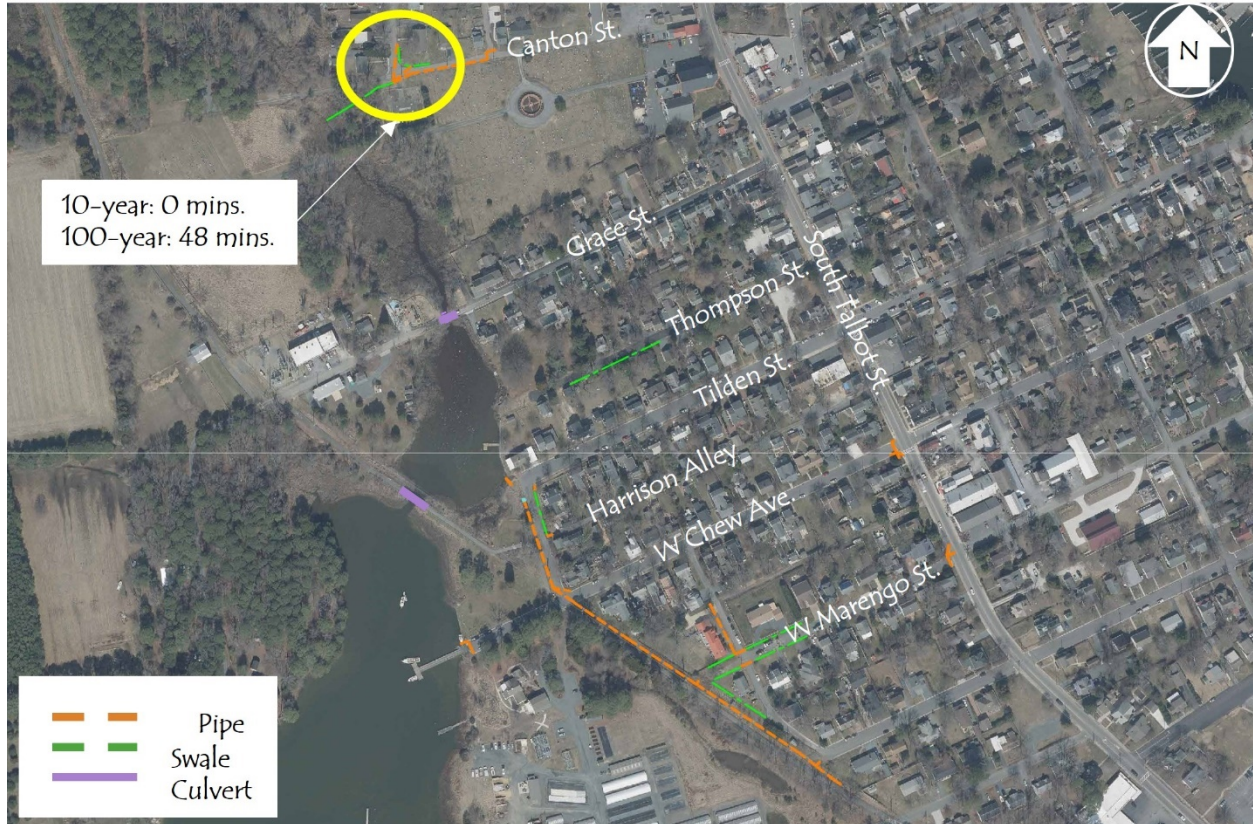
Figure 8 – 2050 Stormwater Flooding duration at Canton St. and Gloria Avenue

The duration of stormwater flooding was evaluated for the 10-year and 100-year return period rainfall event with current and future conditions. The result of the flood duration modeling for Canton Street at Gloria Avenue is shown in Figure 8 and indicate that the 2050 10-year return period rainfall event will not result in flooding while the 2050 100-year return period rainfall event will result in flooding that is likely to drain in less than 1 hour.

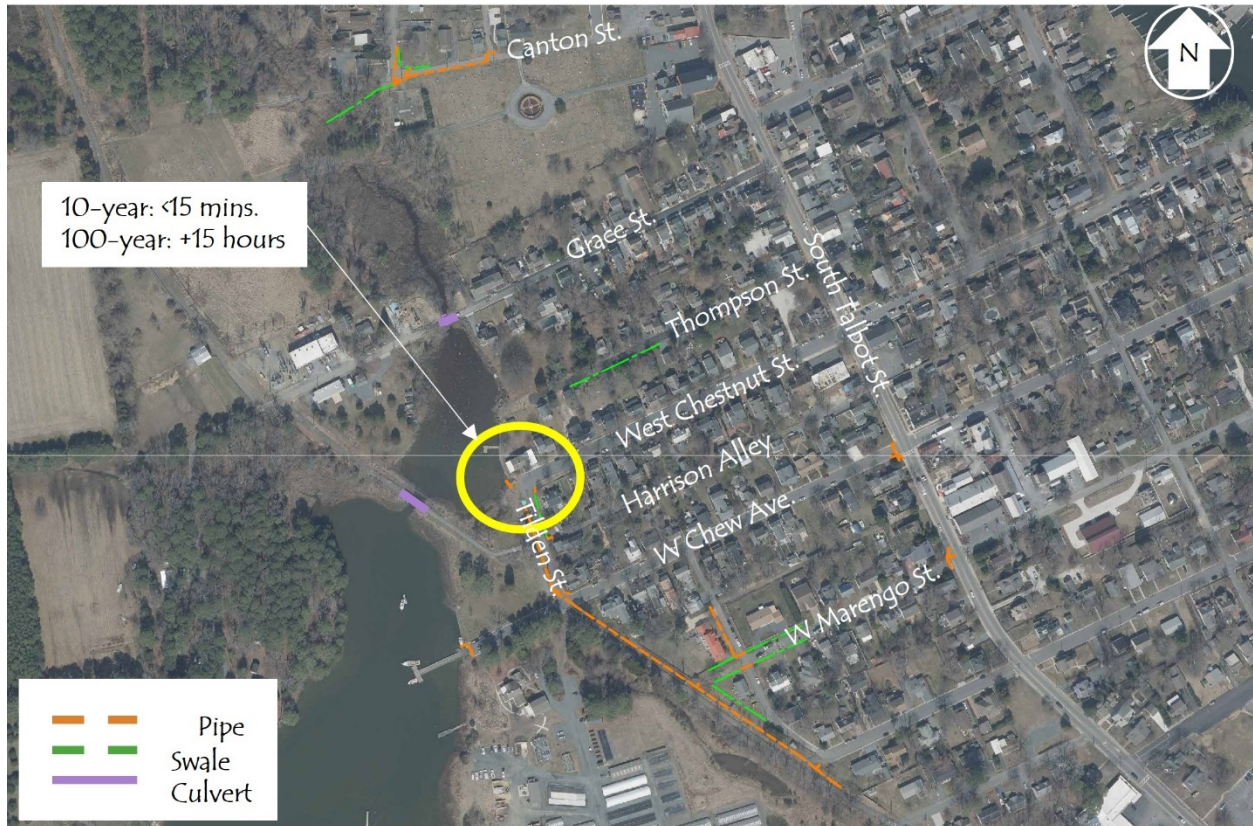
Figure 12 - 2050 Stormwater Flooding Duration at West Chestnut St. and Tilden St.

The duration of stormwater flooding was evaluated for the 10–year and 100–year return period rainfall event with current and future conditions. The results of the flood duration modeling for the retention pond located at West Chestnut St. and Tilden St. is shown in Figure 12.

The results of the modeling show that the higher tailwater elevations at the outfall pipe will prevent drainage of the outfall pipe and result in a significant increase in flood duration at this location for 2050 conditions.

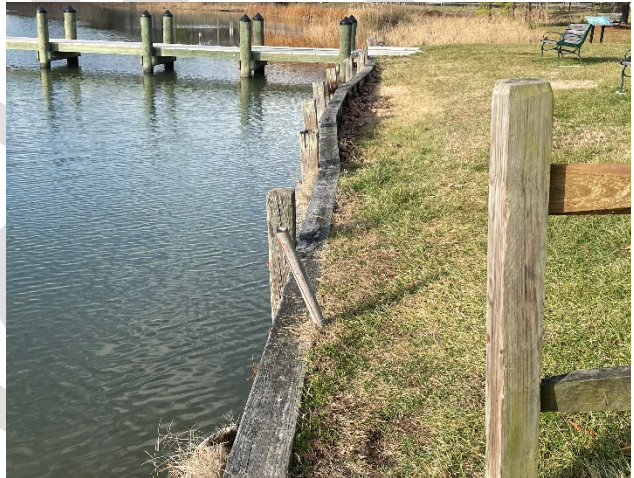
Photo 29 - Failed Bulkhead along Back Creek Park

Back Creek Park is an open space recreational area located west of Tilden Street at the end of West Chew Avenue. The park consists of lawn and tree areas with benches (Photo 25 and Photo 26) that slope down to a bulkhead and living shoreline. The living shoreline consists of small stone sills protecting an area of marsh plantings and other shoreline vegetation (Photo 27). A bulkhead in failed conditions run the remaining

length of shoreline along San Domingo Creek (Photo 28). Water access infrastructure, including kayak racks and piers for docking and launching are also present along the shoreline within the Park (Photo 29 and Photo 30).

The bulkhead along Back Creek Park is in a failed condition. Elevations along the shoreline are low and unlikely to provide adequate flood protection for the park and marina infrastructure in 2050. The park area and marina infrastructure is anticipated to experience frequent flooding. No flooding due to 2050 extreme rainfall events is anticipated at this location.

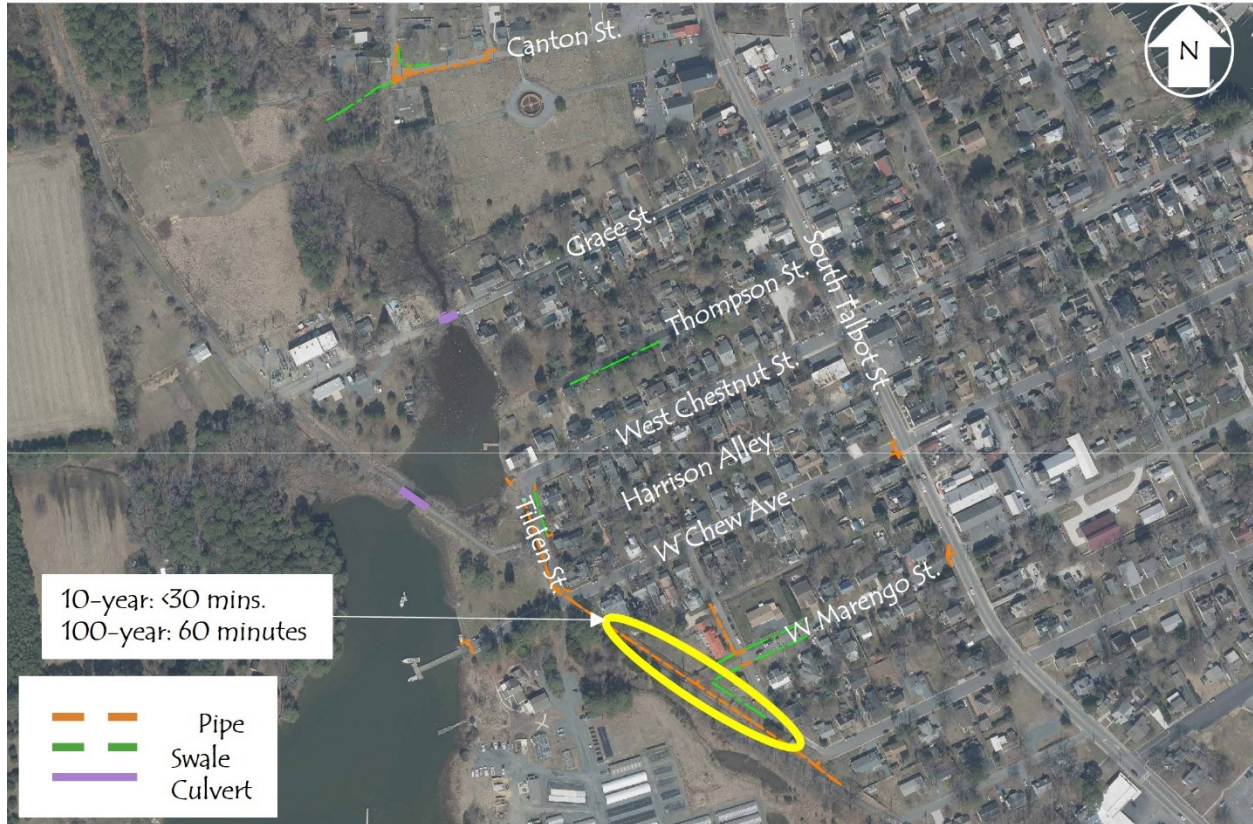
Figure 15 - 2050 Stormwater Flooding Duration at St. Michaels Nature Trail

The duration of stormwater flooding was evaluated for the 10-year and 100-year return period rainfall event with current and future conditions. The results of the flood duration modeling for the St. Michaels Nature Trail indicate that stormwater flooding for the 2050 10-year event will result in less than 30 minutes of flooding while the 100-year rainfall event is likely to result in more than 1 hour of flooding in the portion of trail near West Marengo St.

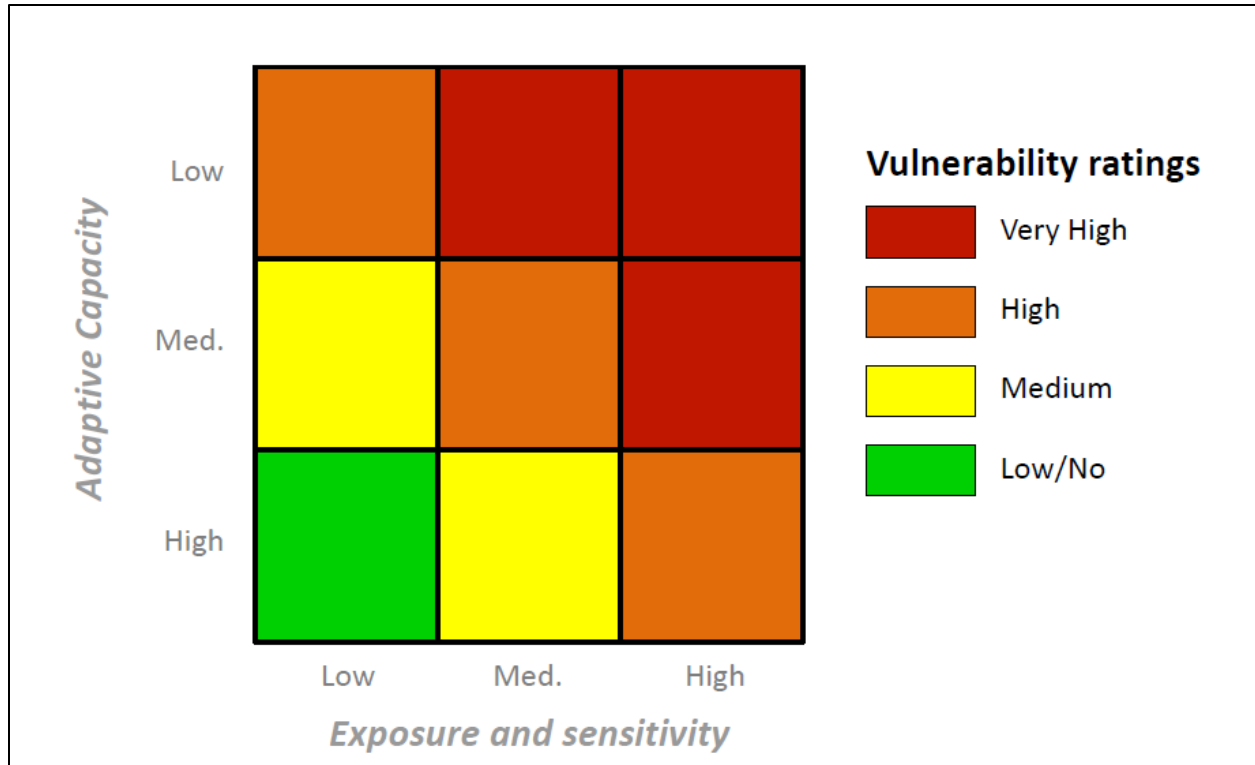
Figure 16 - Determination of Vulnerability Ratings

These metrics were assessed and combined to determine the vulnerability of each area as shown by the diagram in Figure 16. The results of the vulnerability analysis of each assessment area is presented in Table 8

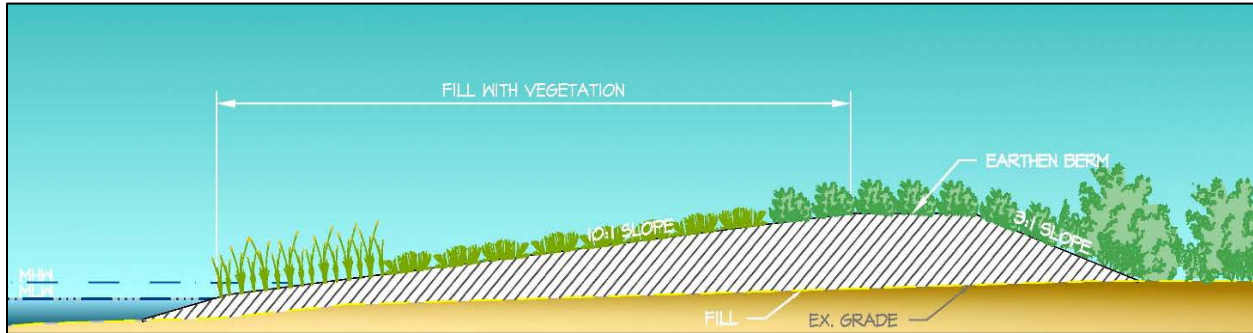
Figure 17 – Earthen Berm with Living Shoreline

For areas along the natural shoreline where additional habitat could be implemented, an earthen berm can be constructed with a living shoreline on the seaward edge. The living shoreline would provide additional elevation and a wider buffer for the flooding as well as environmental benefits.

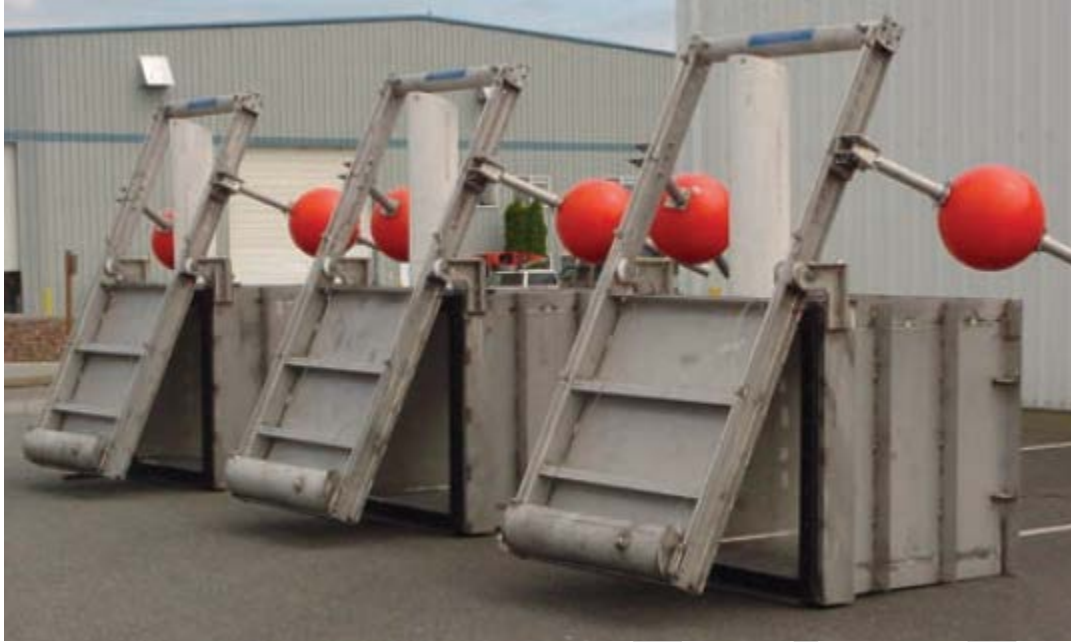
Figure 21 - Self-Regulated Tide Gate (source: Golden Harvest, Inc)

Advantages of this mitigation strategy is the minimal impact to the existing shoreline. As these structures are typically installed downstream of the area they are protecting, the shoreline, vegetation and areas immediately adjacent to the shoreline are not impacted and require little to no improvements. Additionally, installation of a tide gate can reduce the flood risk for many areas upstream of the gate location along San Domingo Creek. Finally, no adjustments to the existing stormwater drainage system will be required as a result of this alternative. Disadvantages of this alternative include grant funding limitations as it does not include environmental uplift. Maintenance and operations may also be required depending on the product chosen. It is also likely this alternative will have a high initial construction cost.

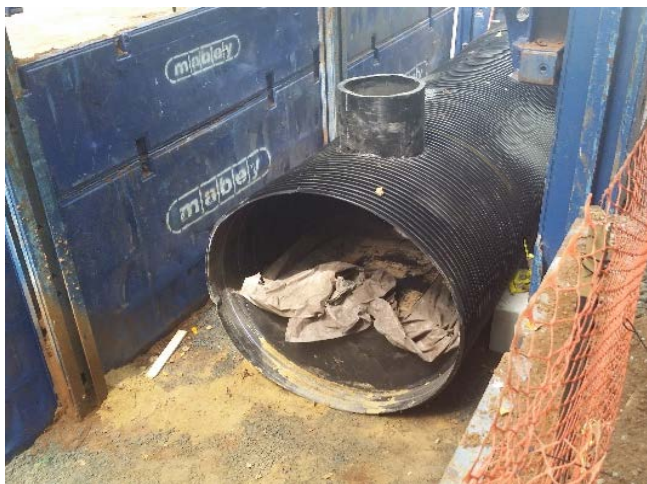
Photo 36 - Pipe Replacement

Increasing pipe sizes is limited by the existing topography, storm drain system elevations and other underground infrastructure, but can be used to mitigate flooding at the upper reaches of the system by efficiently conveying the flow to outlets. This approach can be used widely to mitigate flooding in areas where above ground practices are not feasible. The design must consider the increased flow being routed to the central storm drain conduits to ensure they do not become inundated.
